# Manhole Inspection Summary

Manhole # S33EE\_057MH

**Location** Address: **1212 MARTIN LUTHER KING JR BLVD** Cross Street: **W BIDDLE ST**

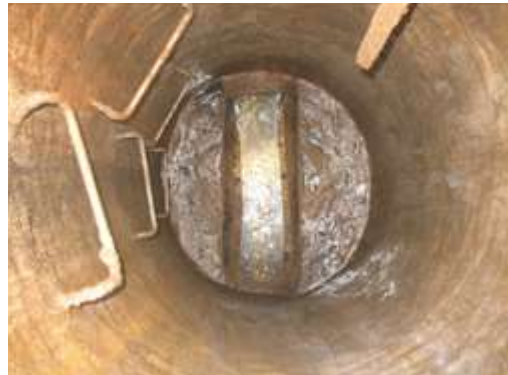
Top View

Bench debris.

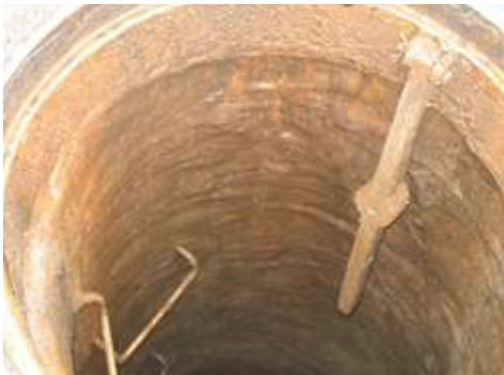
Defect

Frame leaks. Adjustment infiltration - other side.

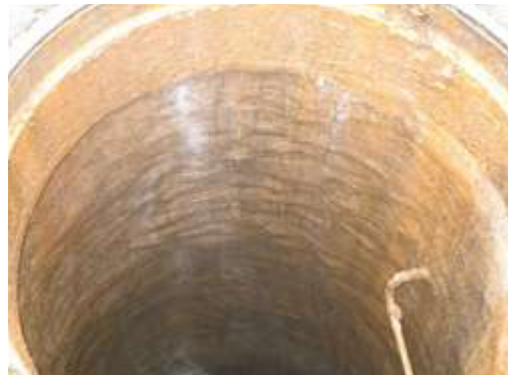
Defect

Frame leaks. Adjustment infiltration.

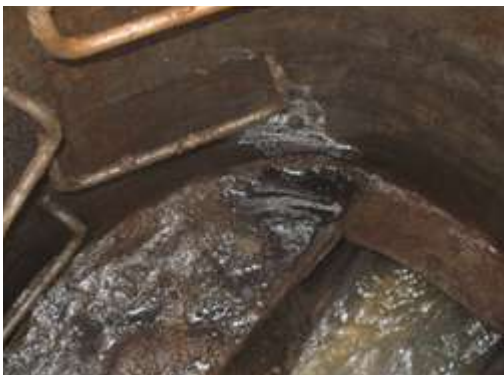
Defect

Pipe seal or Bench infiltration.

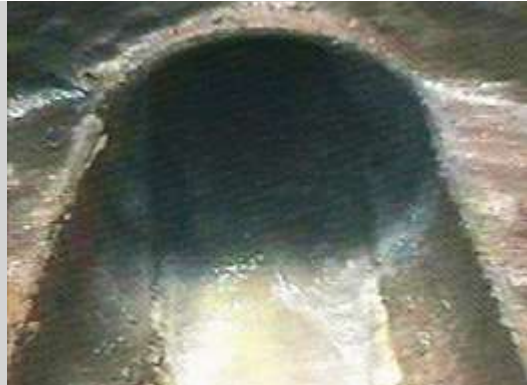
### 18 in. Circular Gravity Sewer Pipe Out @ 12 O'Clock

Infiltration: **Evidence** Pipe Seal Cond: **Unknown**
